JOHN DAY RIVER SUB-BASIN FISH HABITAT ENHANCEMENT PROJECT

1998 Annual Report

Oregon Department of Fish and Wildlife

Project Number 84-021-00
Contract Number DE-AI79-84BO17460

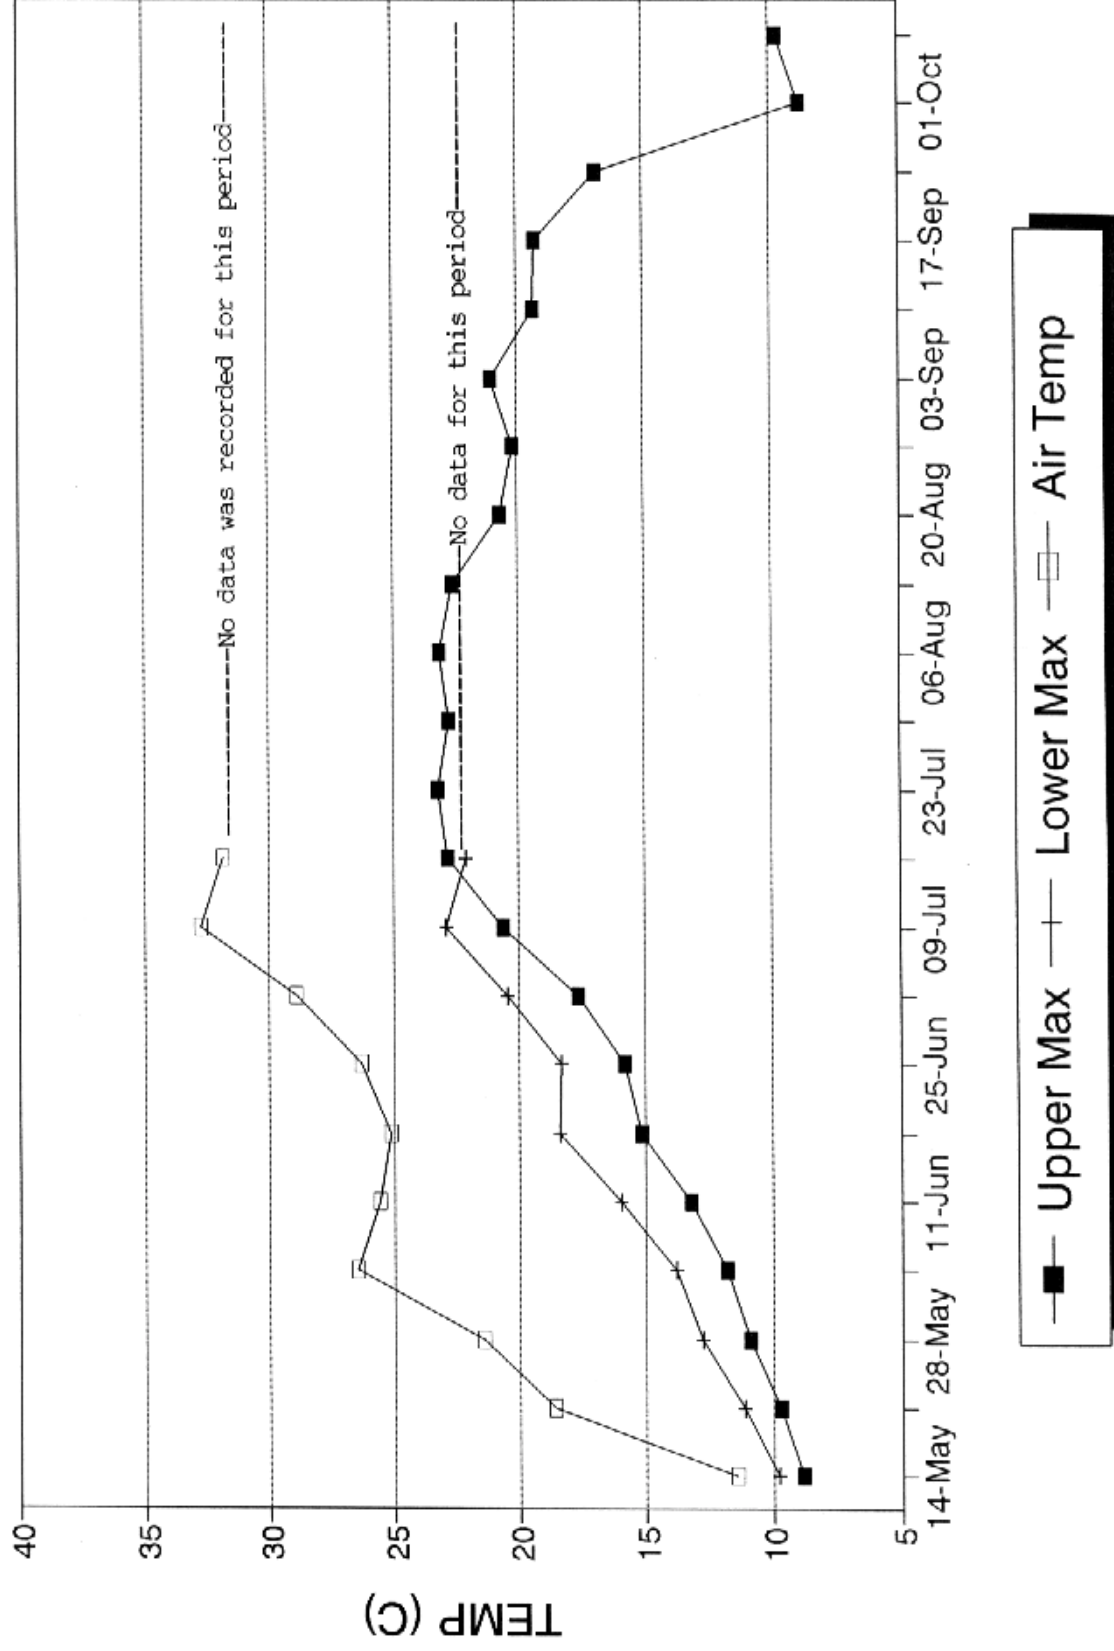
1998 COTTONWOOD CREEK

Ave. Weekly Maximum Water Temperatures

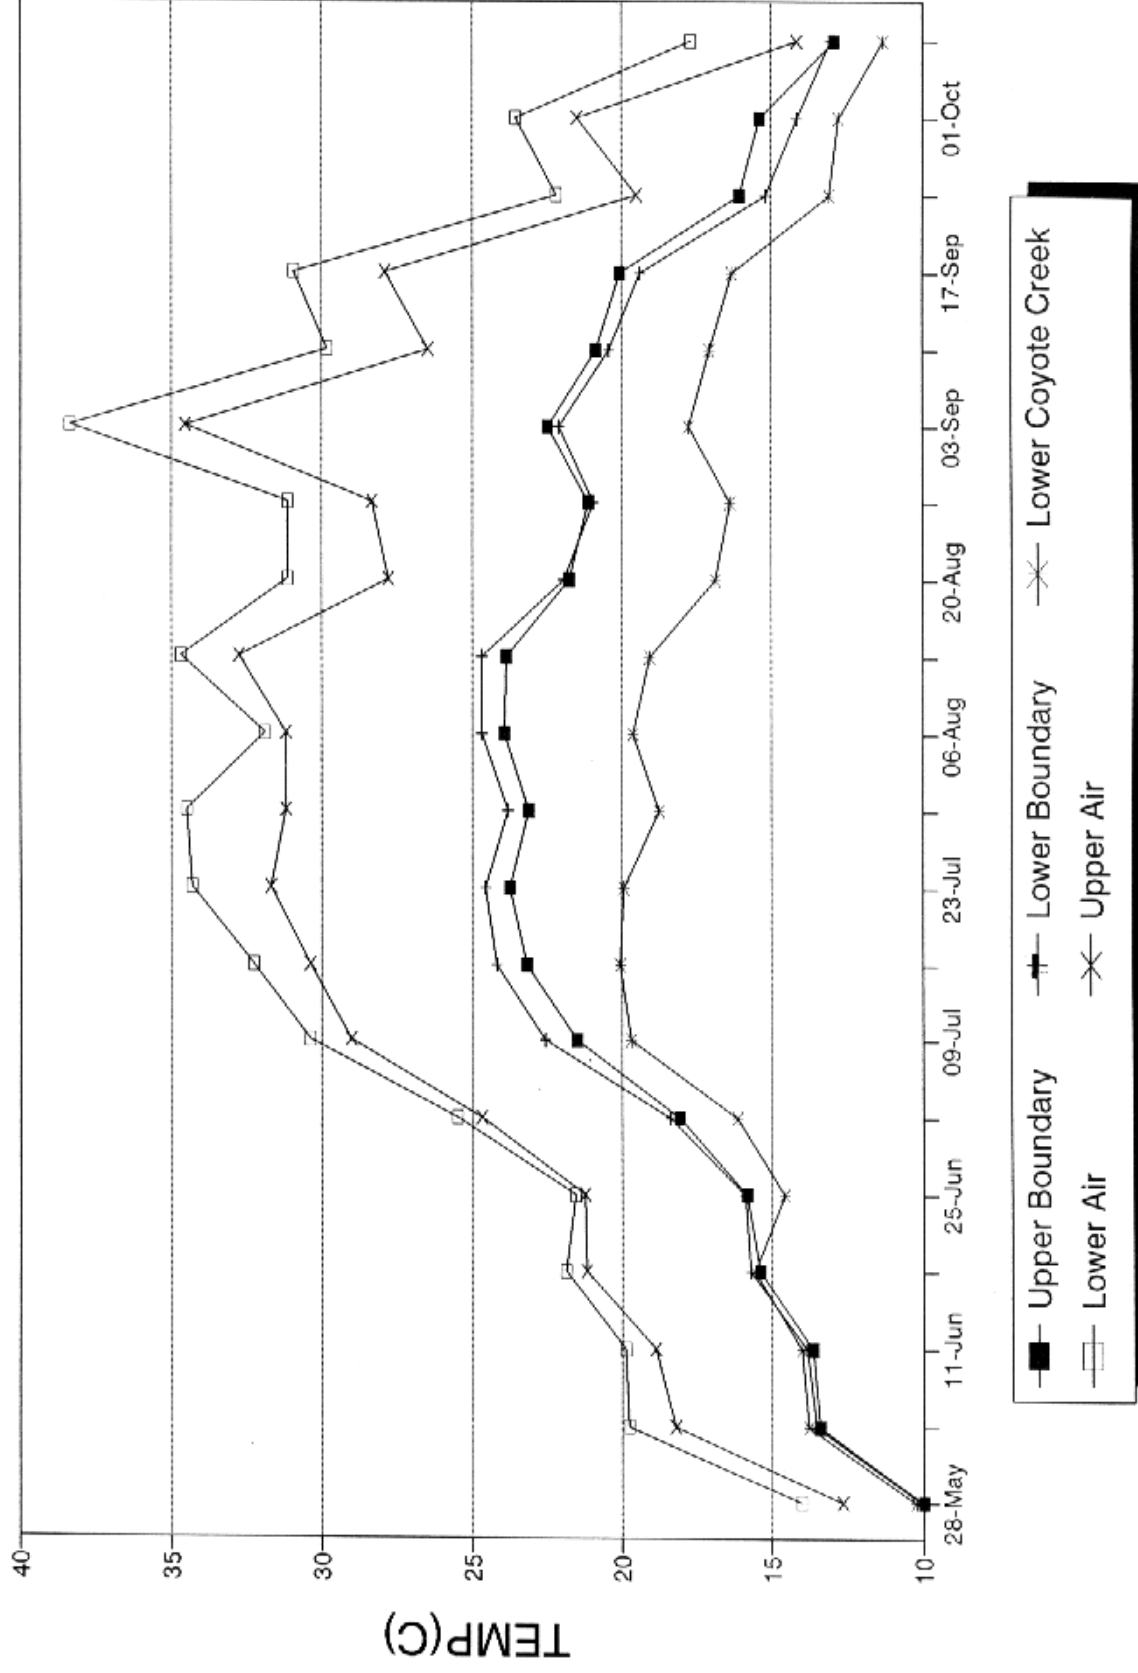
1998 MIDDLE FORK NATURE CONSERVACY

Ave. Weekly Maximum Water Temperatures

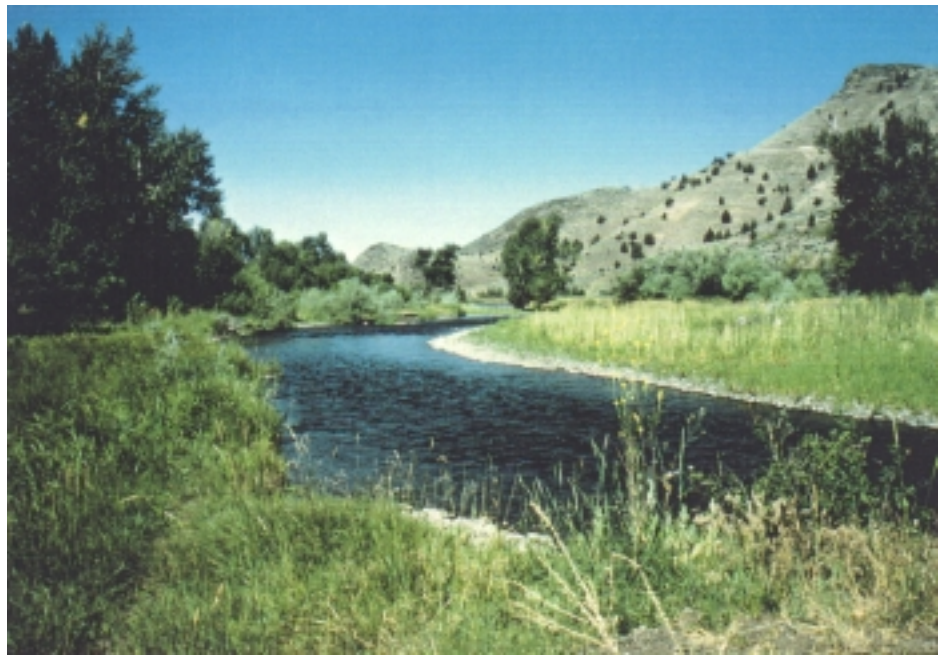
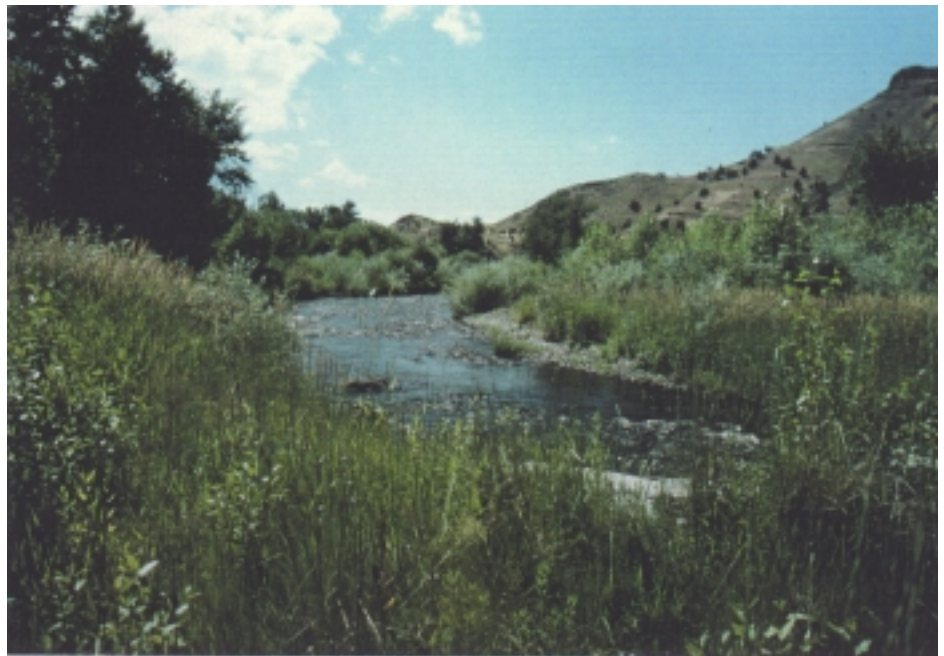
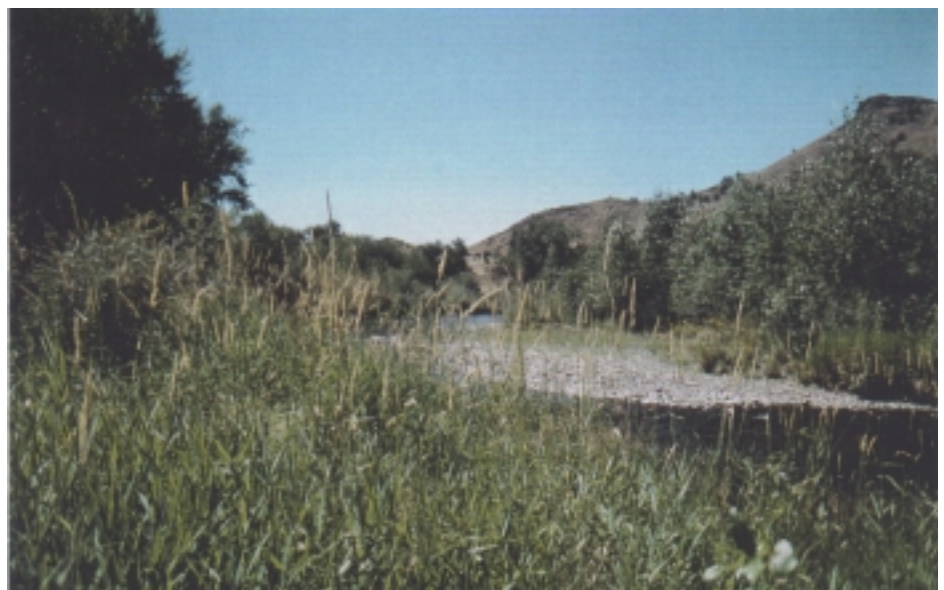
By 1995 the gravel bar had stopped moving and was collecting silt in-between the stalks of new trees. Vegetation had solidified the banks and deepened the river.

A flood in 1997 deposited more gravel on the corner, only now it raises the river level instead of eroding the opposite bank (bottom photograph). This benefits the landowner by sub-irrigating the surrounding pastures and improves fish habitat by increasing the depth of upstream pools.

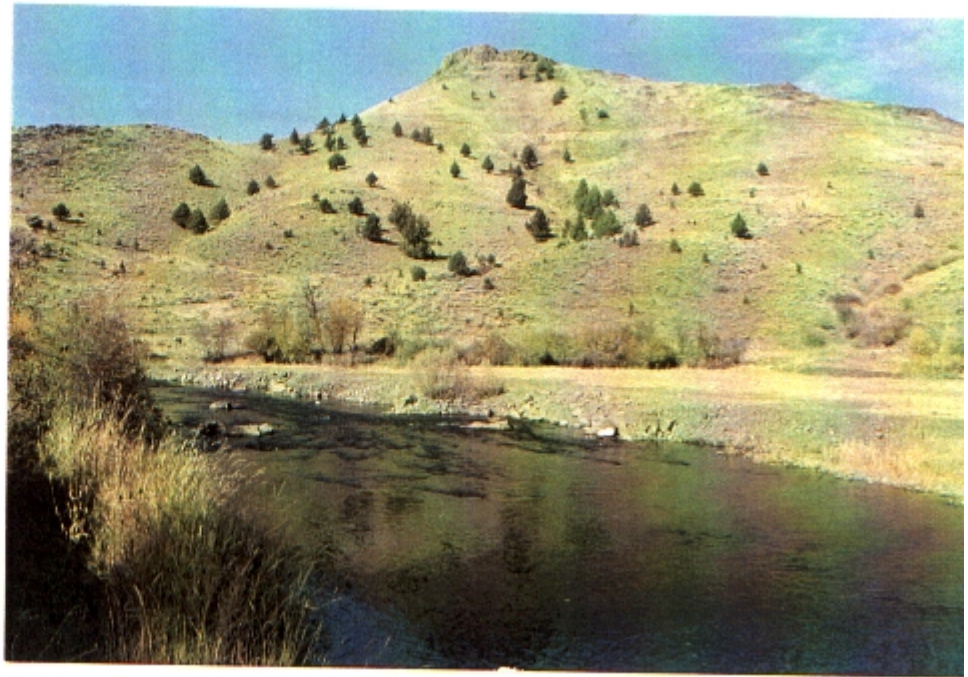
AINSTEM JOHN DAY RIVER
CNEIL PROPERTY
BOVE CITY OF JOHN DAY
987 1992 1998

1987 this section of river was suffering severe bank erosion impacting the adjacent hay field.. Jetties and riprap were constructed to remedy the problem.

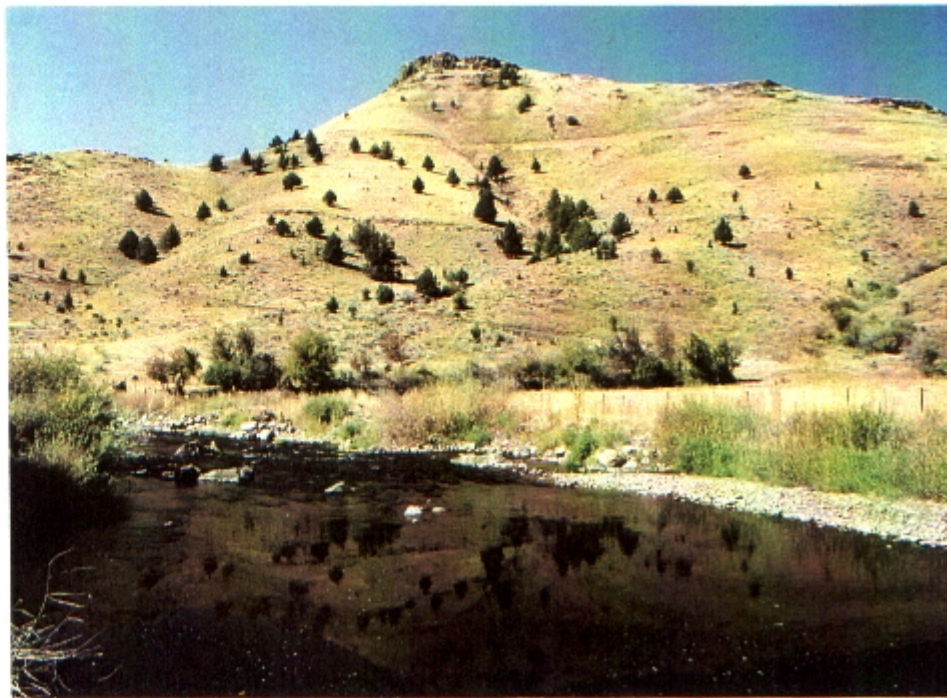
For the first three years reed canary grass covered the entire site but by 1992 young willow and cottonwood began to appear.

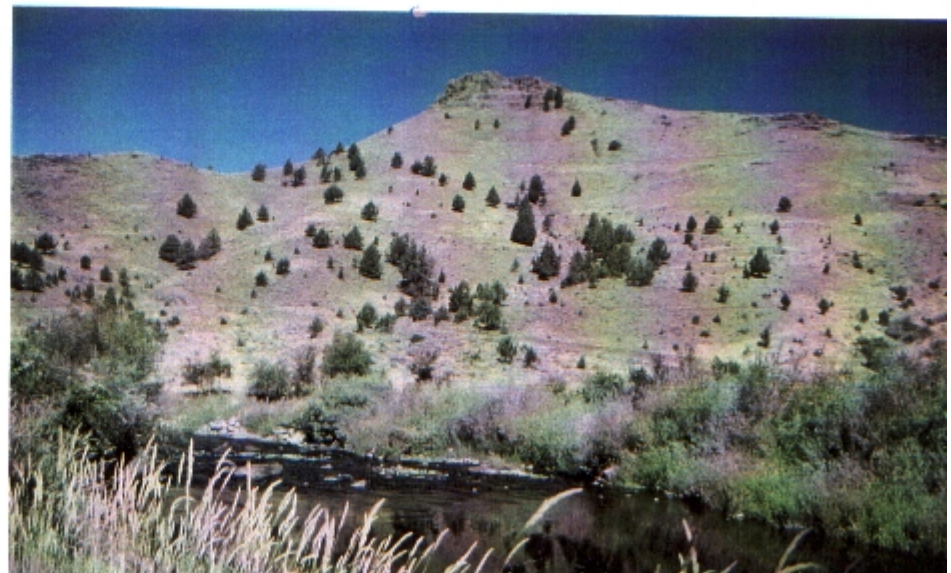
Today the reed canary grass has been reduced to the water's edge and the willow and cottonwood are growing at a rate of 2 feet per year.

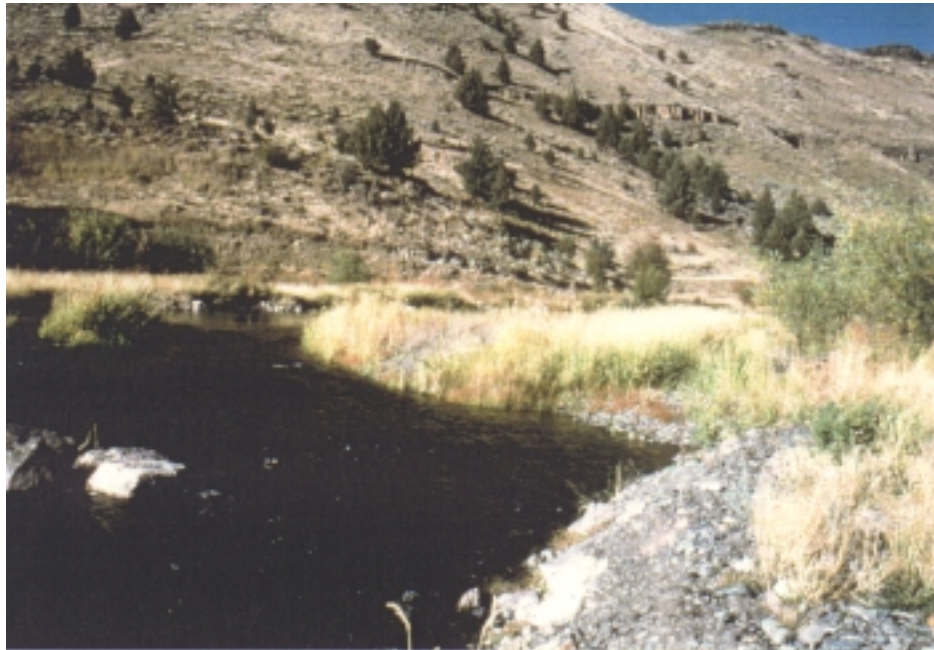
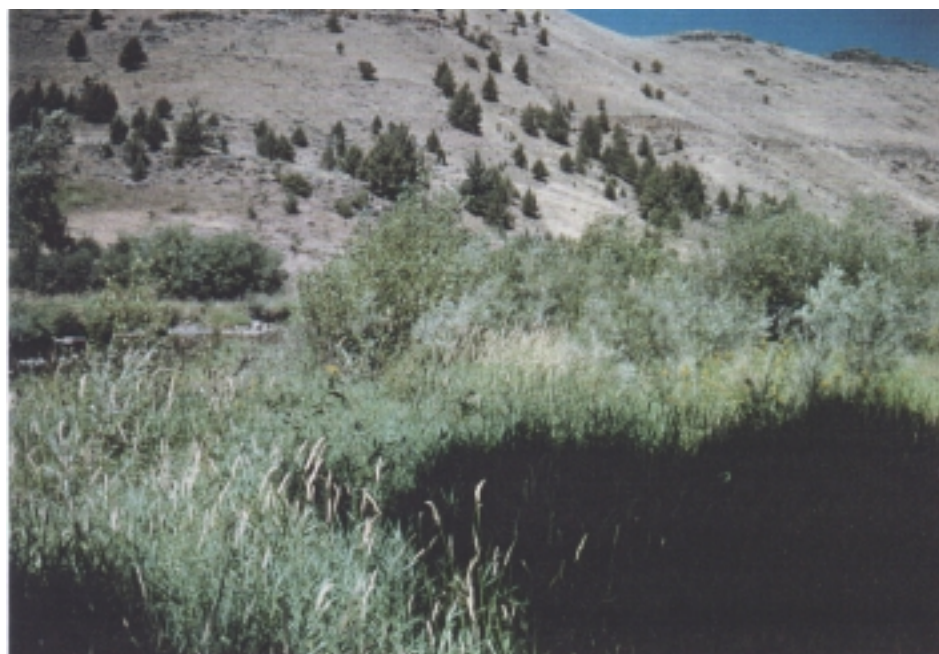
MAINSTEM JOHN DAY RIVER MCNEIL PROPERTY 1988

These photos were taken looking upstream at a depositional area. They illustrate vegetation can transform stream banks from open gravel to dense forests. This not only benefits fish but wildlife also. The surrounding uplands are very open with little cover. Several wildlife species must leave the uplands and move into this forest to survive during weather extremes and raise their young in the spring.

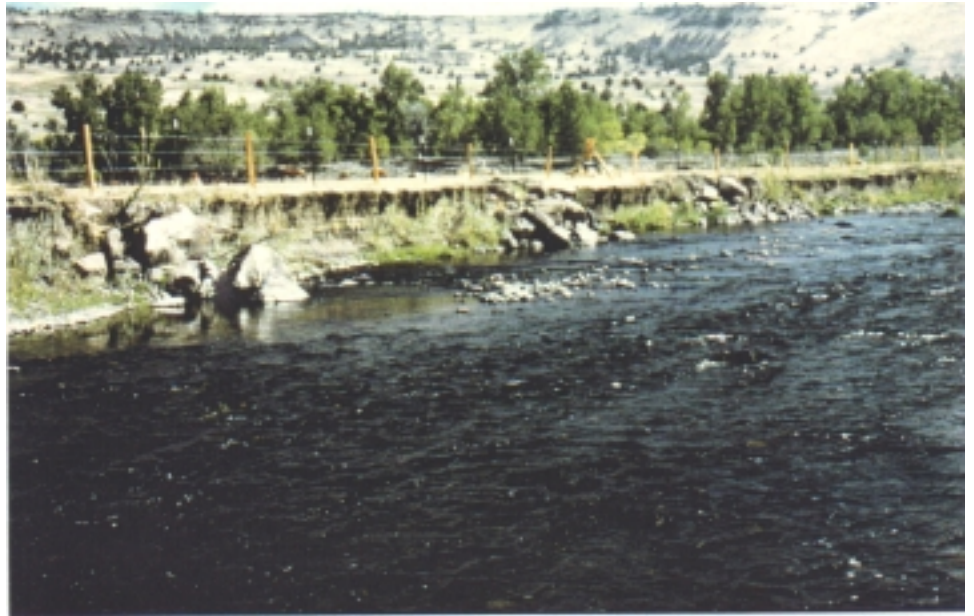
**MAINSTEM JOHN DAY RIVER
HOLMSTROM PROPERTY
AT CITY OF JOHN DAY**

In 1985 this section was a wide, Shallow riffle with poor fish habitat. The far bank was eroding every year and in the spring, cattle would fall in and drown. Jetties and fence were added to remedy these problems.

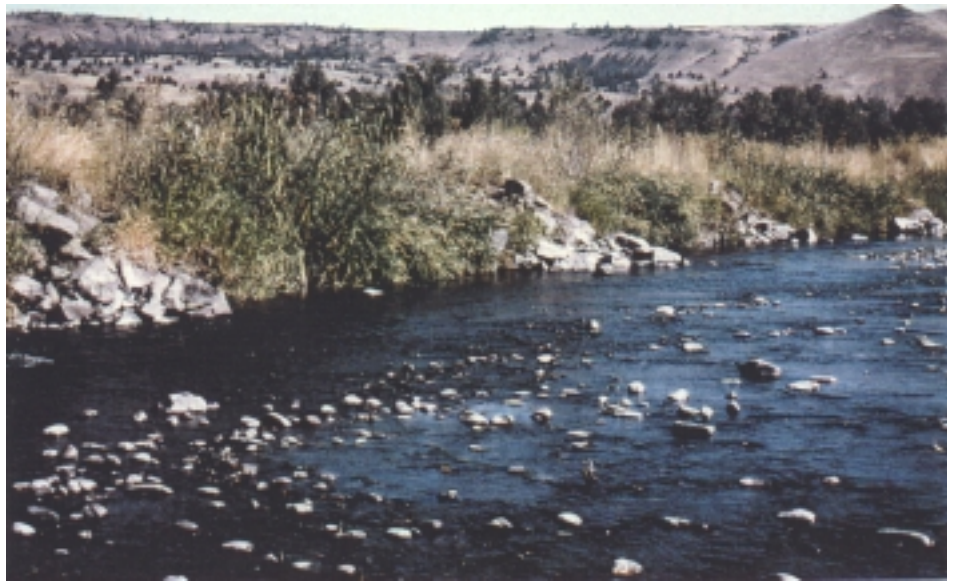
By 1992 the vertical banks had flattened and silt had collected between the jetties.

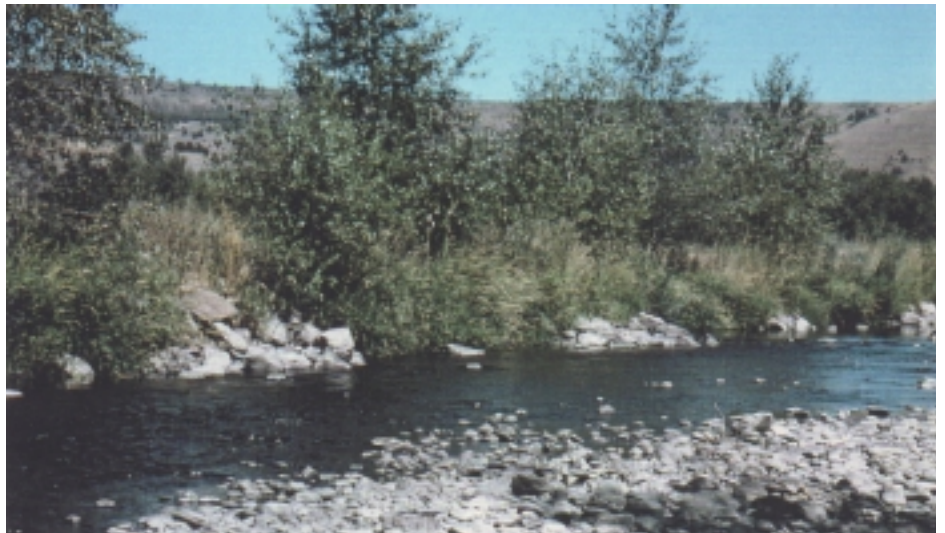
Today the vegetation has solidified the banks and low flows are not as exposed to the sun. High water temperatures and excessive evaporation result from wide, shallow riffles and this is an example of how they can be corrected.

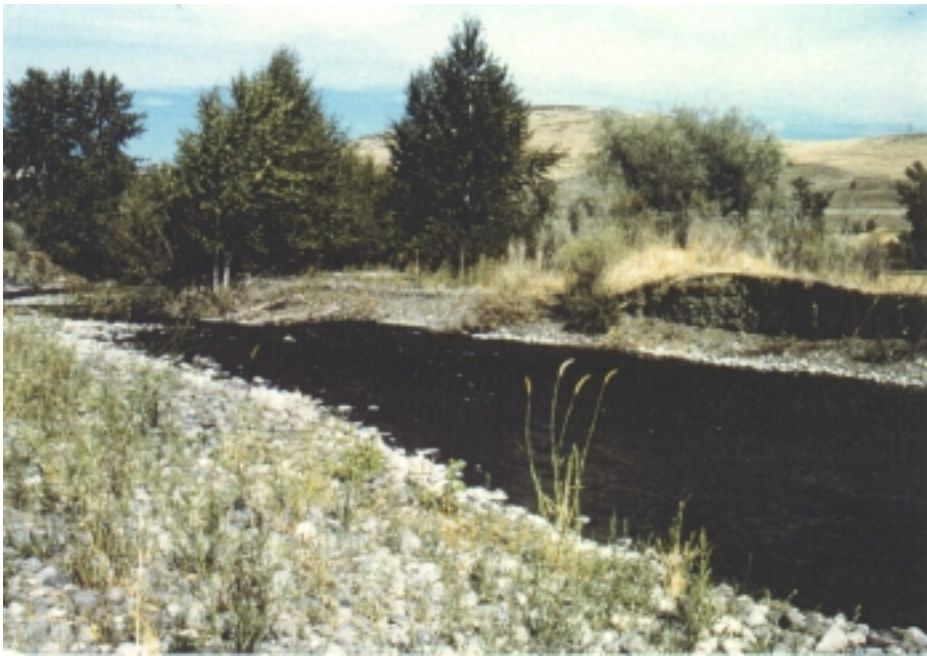
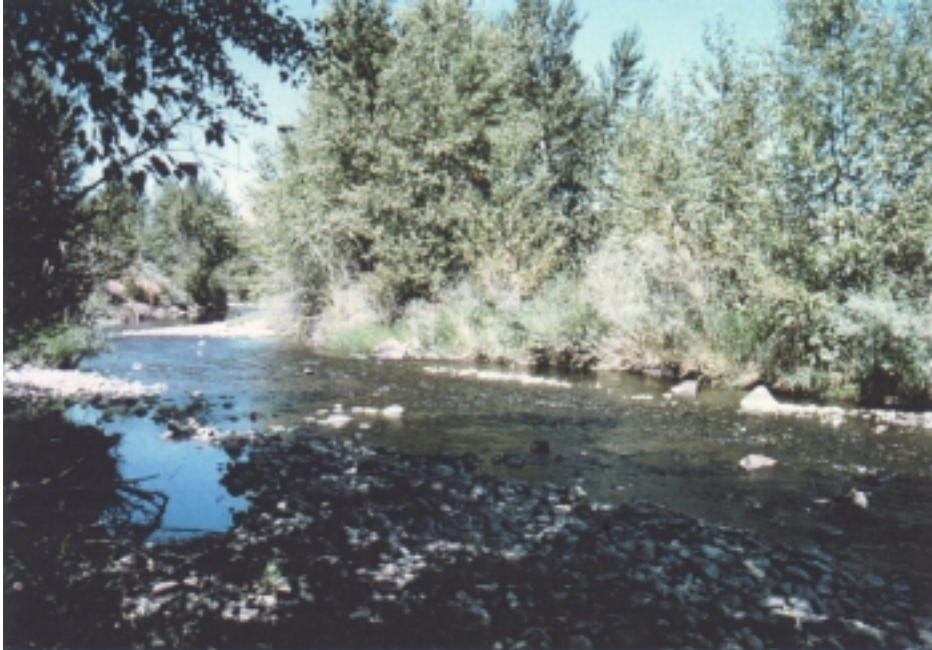
MAINSTEM JOHN DAY RIVER HOLMSTROM PROPERTY 1985

These photos show the amount of shade we now have on some of our project areas. Both were taken at the same site, about 1:00 in the afternoon, 13 years apart.
